# RCRA FACILITY ASSESSMENT REPORT CALGON CORPORATION PASADENA, TEXAS TXD086476850

# U.S. ENVIRONMENTAL PROTECTION AGENCY Region 6 1445 Ross Avenue Dallas, TX 75202

PRC Environmental Management, Inc. 350 North St. Paul Suite 2600 Dallas, TX 75201

February 18, 1993

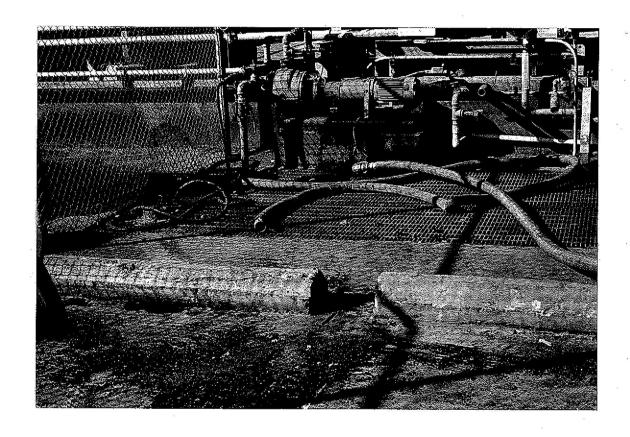
Date: 12/01/92 Location: <u>SWMU No. 9</u> East
Former location of the kiln; note the stains on the concrete. Orientation:
